Monitoring Data Record

Project Title: I-540 Northern Wake Expressway (R-2000AB) COE Action ID: 200021863

Stream Name: UT to Kit Creek DWQ Number: 030918

City, County and other Location Information: Wake County, Site 6 (Sta.10+41 to 12+76 YRPA-)

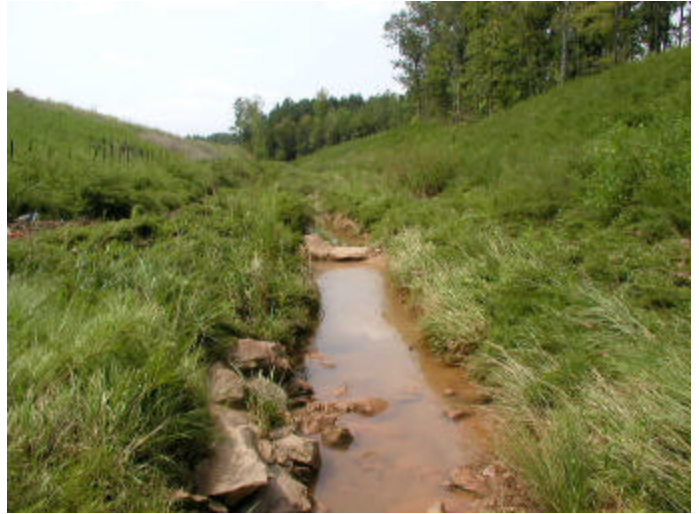
Photo Point #1 (Downstream)

The stream is mostly stabilized for the first year of monitoring. There is some bank erosion on the left bank at approx. Sta. 10+10 and Sta. 12+70. The left arm of the 2<sup>nd</sup> crossvane on the relocation at approx. Sta. 10+50 has eroded (Photo Point #1 Downstream). The Roadside Environmental Field Operations Engineer has been notified about these erosion problems. There was evidence that a bankfull event had occurred at this stream relocation.

Date Inspected	Sta. 10+10 Sta. 12+70	Sta. 10+50	Station Number	Station Number	Station Number
Structure Type		Crossvane			
Is water piping through or around structure?					
Head cut or down cut present?					
Bank or scour erosion present?	Bank erosion on the left bank	Bank erosion on left arm of crossvane			
Other problems noted?
